SWIF – VEGETATION MANAGEMENT CONCEPTS Proposed Levee Vegetation Maintenance Schematics

Rev.: November 10, 2015 - DRAFT

Proposed Levee Vegetation Maintenance Schematics

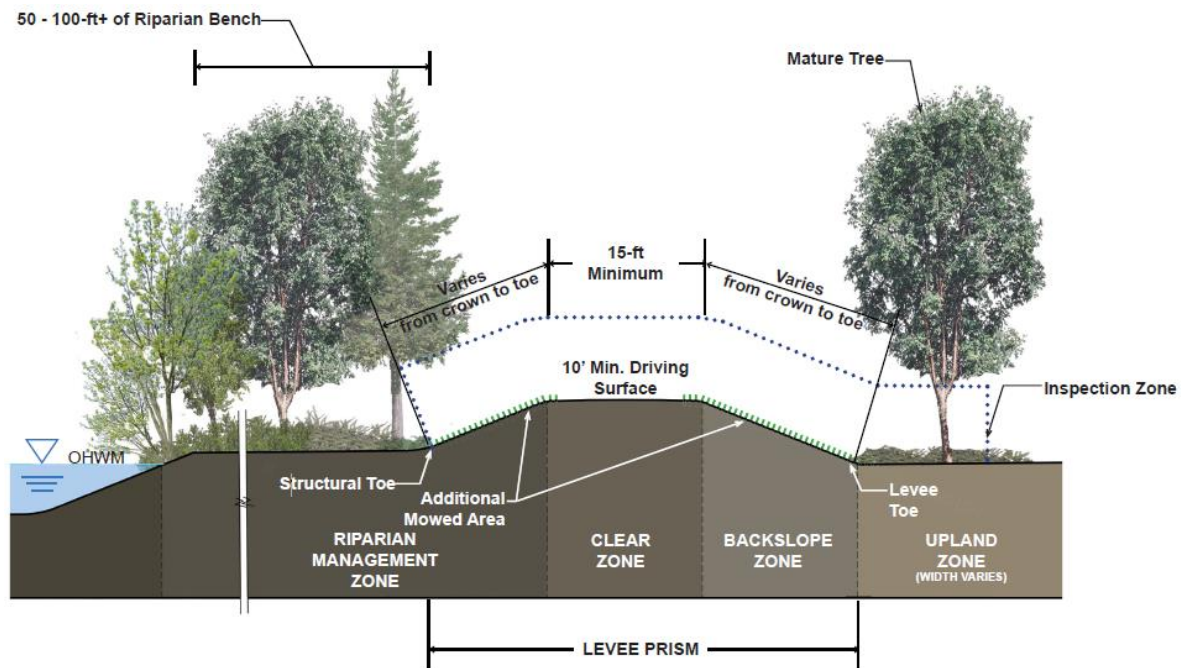
Levee Maintenance Schematic “E” – Setback Levee with Floodplain Bench

This levee x-section depicts levees (known as setback levees) that are 50 feet or more back from the active river channel, with a floodplain “bench” at the riverward toe of the levee that is at least 50 feet wide. If the floodplain bench (vegetated bar) is less than 50 feet wide, Levee Maintenance Schematic “A” or “B” applies. Typically, these floodplain benches are associated with constructed “setback levees”, and reflect the furthest extent that levees can be constructed under current land use constraints. Upon these vegetated bars (floodplain bench), all woody vegetation, trees and native shrubs are preserved and provide riparian functions including bank stability, roughness, cover, shade, wood recruitment, nutrient contribution, water quality filtering and moderation of water temperature. The levee prism will be maintained in grass for routine maintenance and inspection purposes.

This approach recognizes that levees located 50 feet or more from the active channel provide for a greater level of riparian function compared to the other schematics, and can therefore be maintained in grass with less ecological impact. However, over time the river may migrate towards the levee and be less than 50 feet away, and vegetation maintenance may need to change accordingly. If the river migrates to within 50 feet of the levee toe, the maintenance practices switch to Section “A” or “B” methods. If the river migrates further than 50 feet away from the Type “A” or Type “B” levee embankment, maintenance practices switch to those for Type “E”.

The levee is maintained for ease of levee maintenance and for inspection purposes. A “Clear Zone” is provided across the crest of the levee to remain clear of woody vegetation for vehicle access for purposes of maintenance work and in times of emergency. The Clear Zone will extend to the toe of the slope or as necessary down the slope to control growth of invasive plants and branches through routine mowing and limbing of tree branches that may crowd the clear zone and for maintenance efficiency. The backslope will be managed to provide visibility for inspection of possible seepage and structural integrity issues. An “Upland Zone” is provided beyond the landward toe as available for long-term enhancement and conservation protection.
